17th Street and London Avenue Canals

17th Street Canal

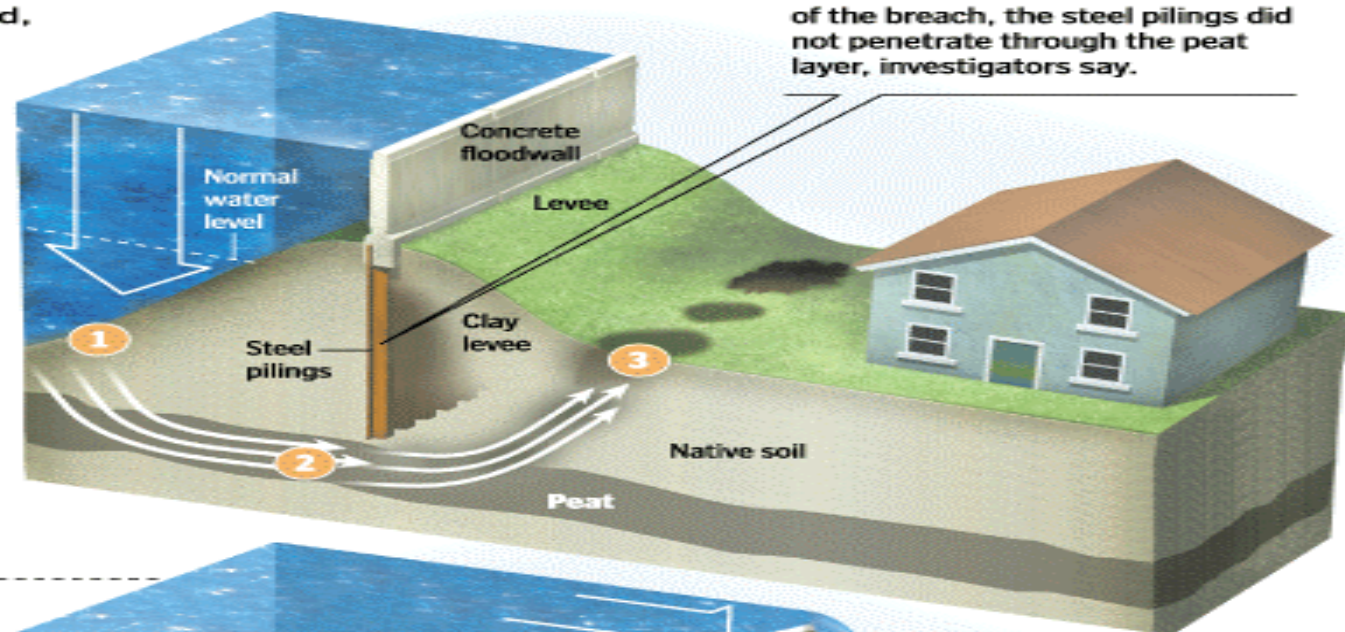
The levee at the 17th Street Canal was built atop soils that included a layer of soft, organic soil called peat. At the 17th Street Canal breach, water traveling through the peat layer may have weakened the levee's foundation, investigators say. The levees along the London Avenue Canal failed in a similar fashion.

1 Water seeps through soil levees under normal conditions. During the storm, as water rose in the canal, water pressure increased, and seepage increased.

2 Peat is a weak soil. Water seeping into the peat layer had an easy path under the levee and weakened both the peat layer and the soils above it.

3 Water began to create a tunnel in the soils above the peat, at the base of the levee. The base weakened and washed away.

Steel pilings prevent seepage and provide support for the concrete floodwall. But at the site of the breach, the steel pilings did not penetrate through the peat layer, investigators say.

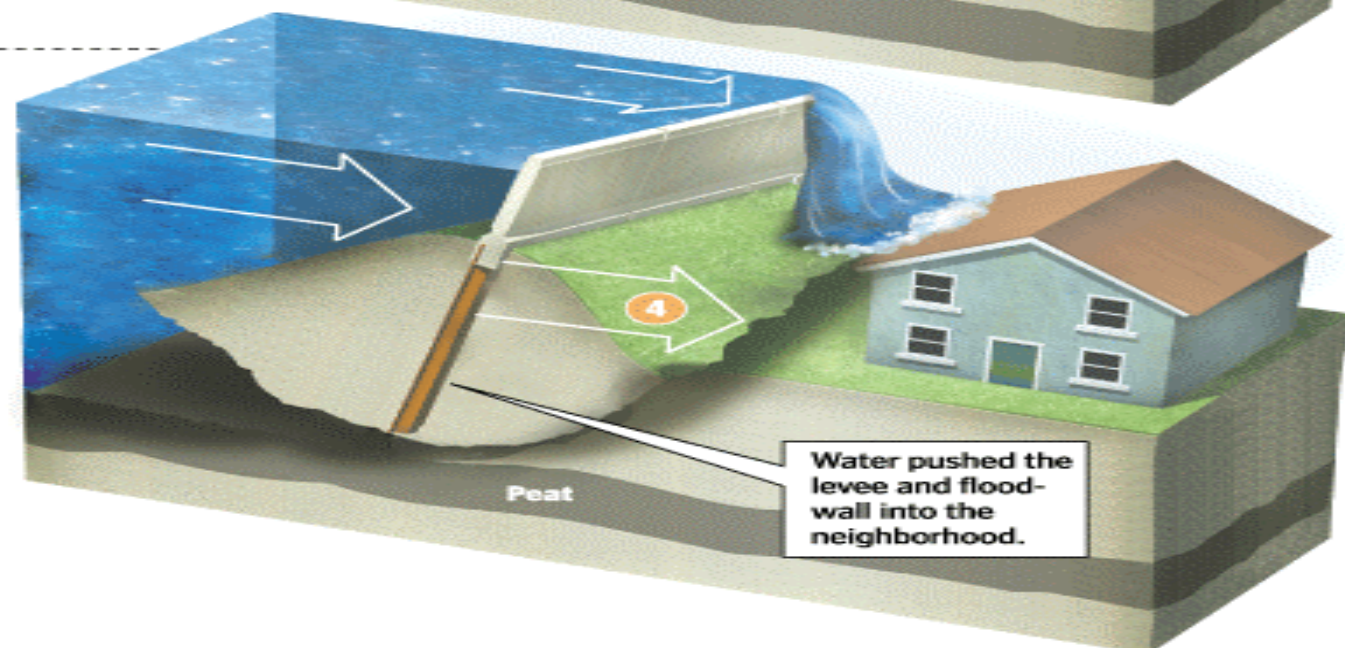
4 The floodwall and levee could no longer resist the force of the water in the canal. Both slid 35 feet into the neighborhood, and water raced in.

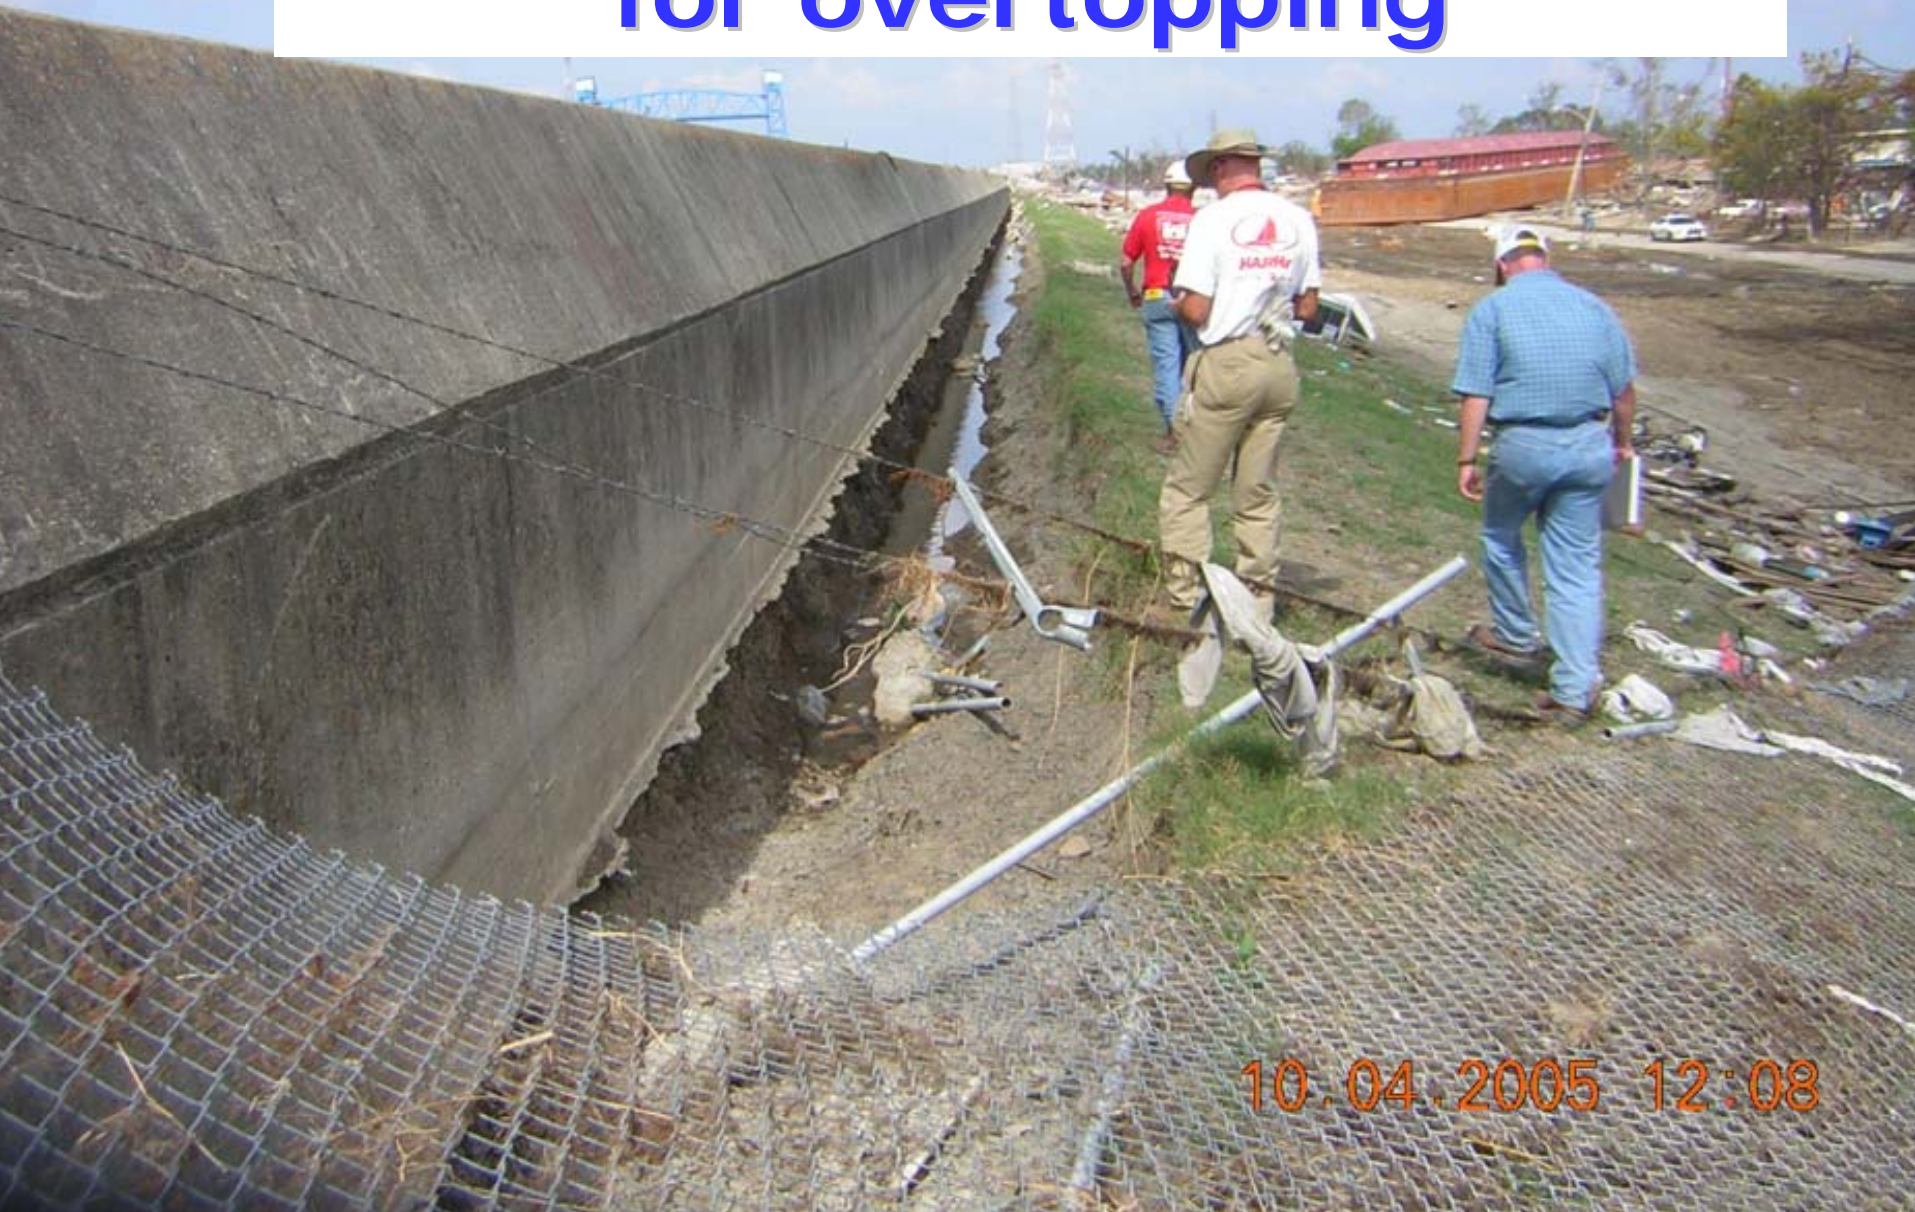
Floodwalls not designed for overtopping

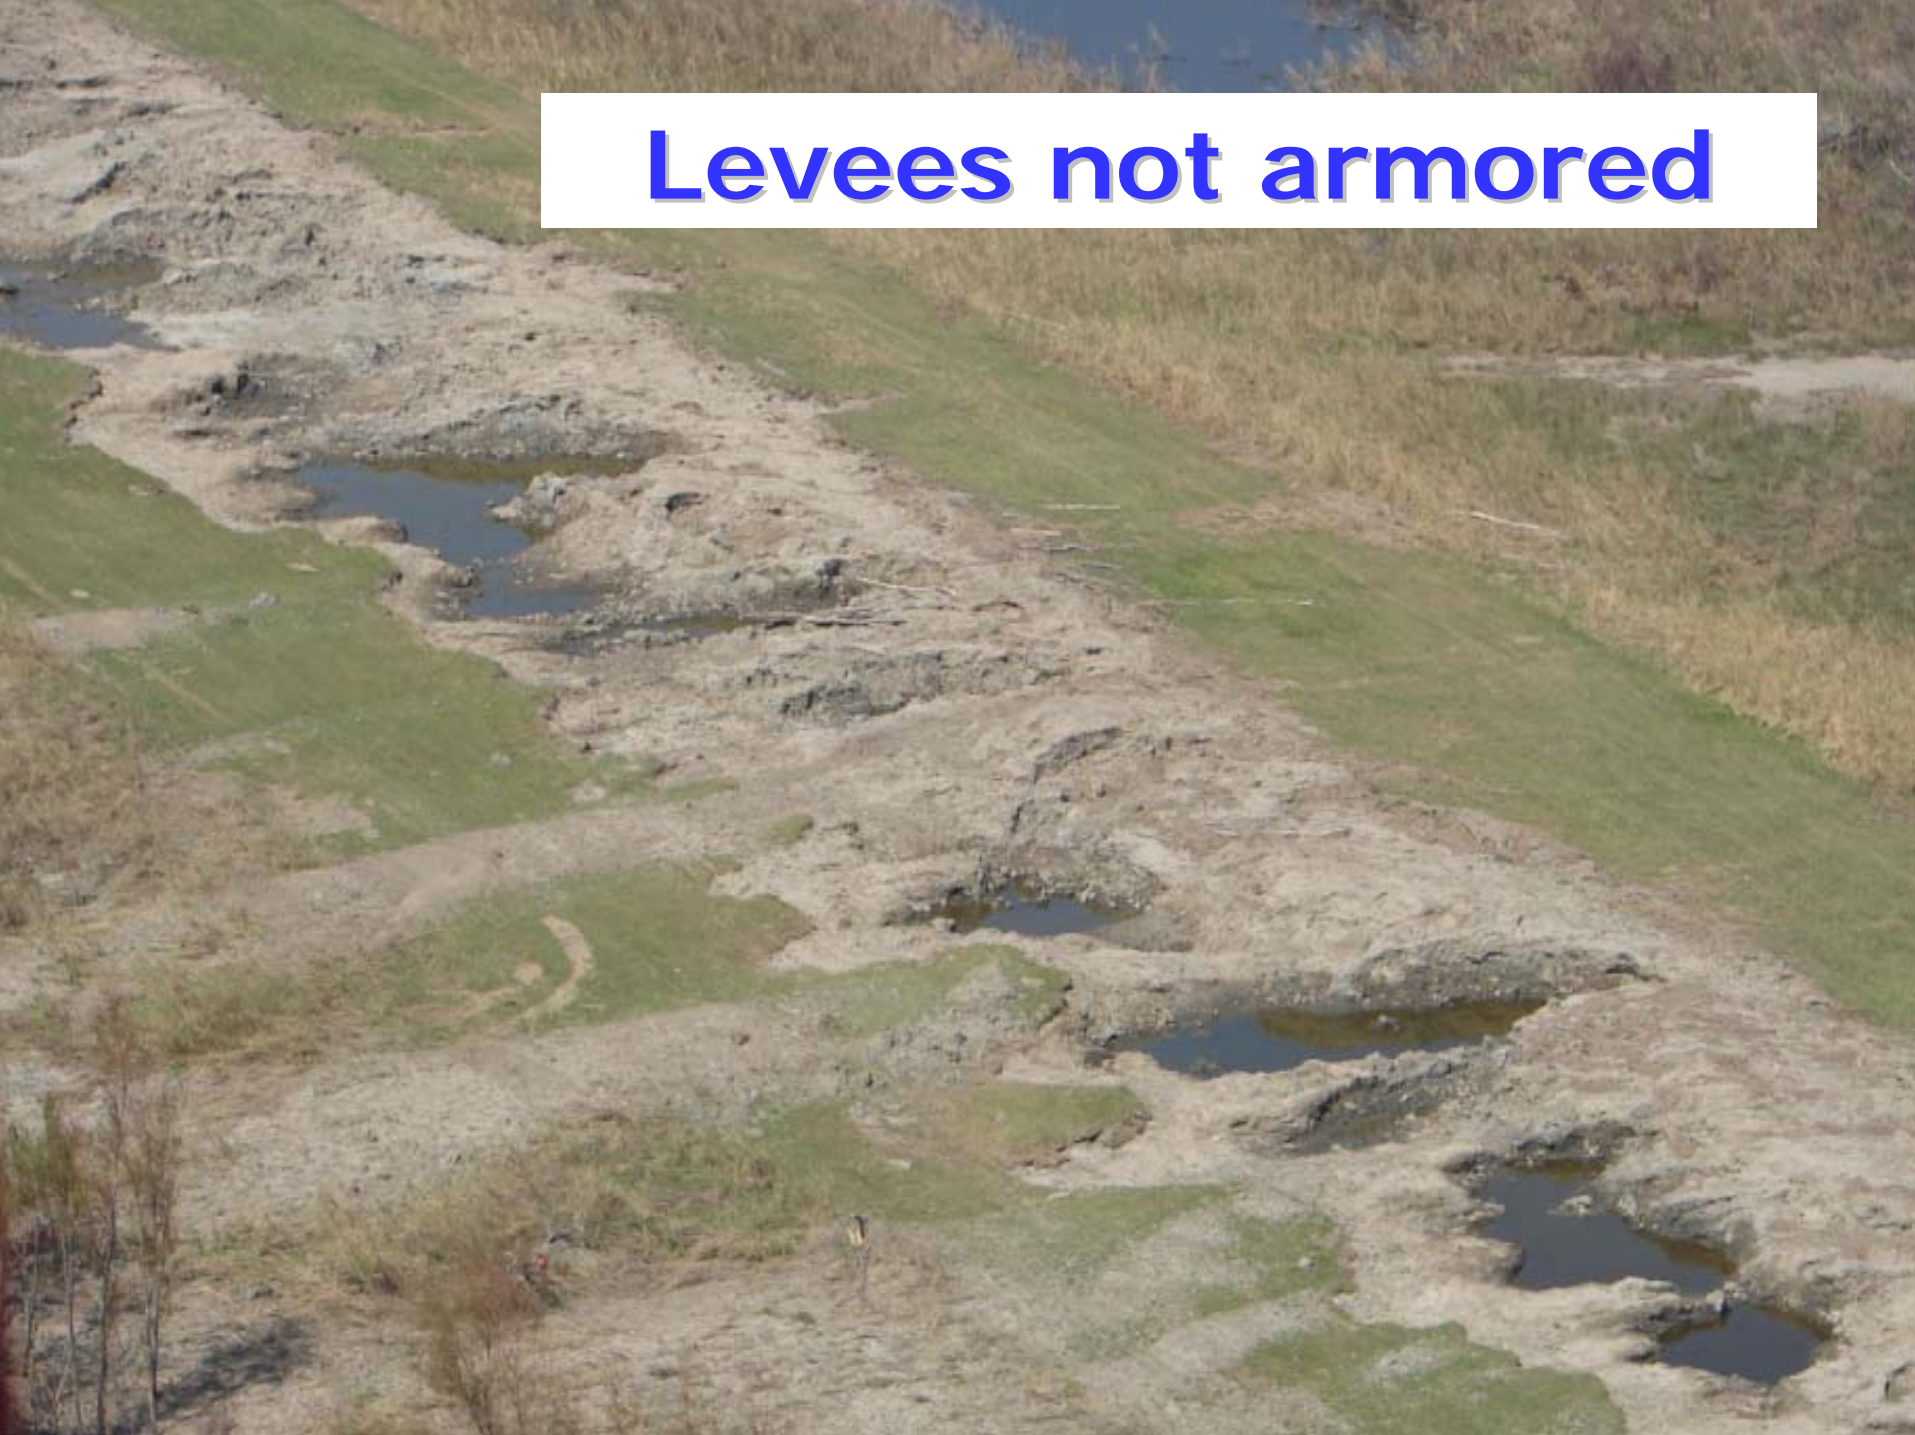
Levees not armored

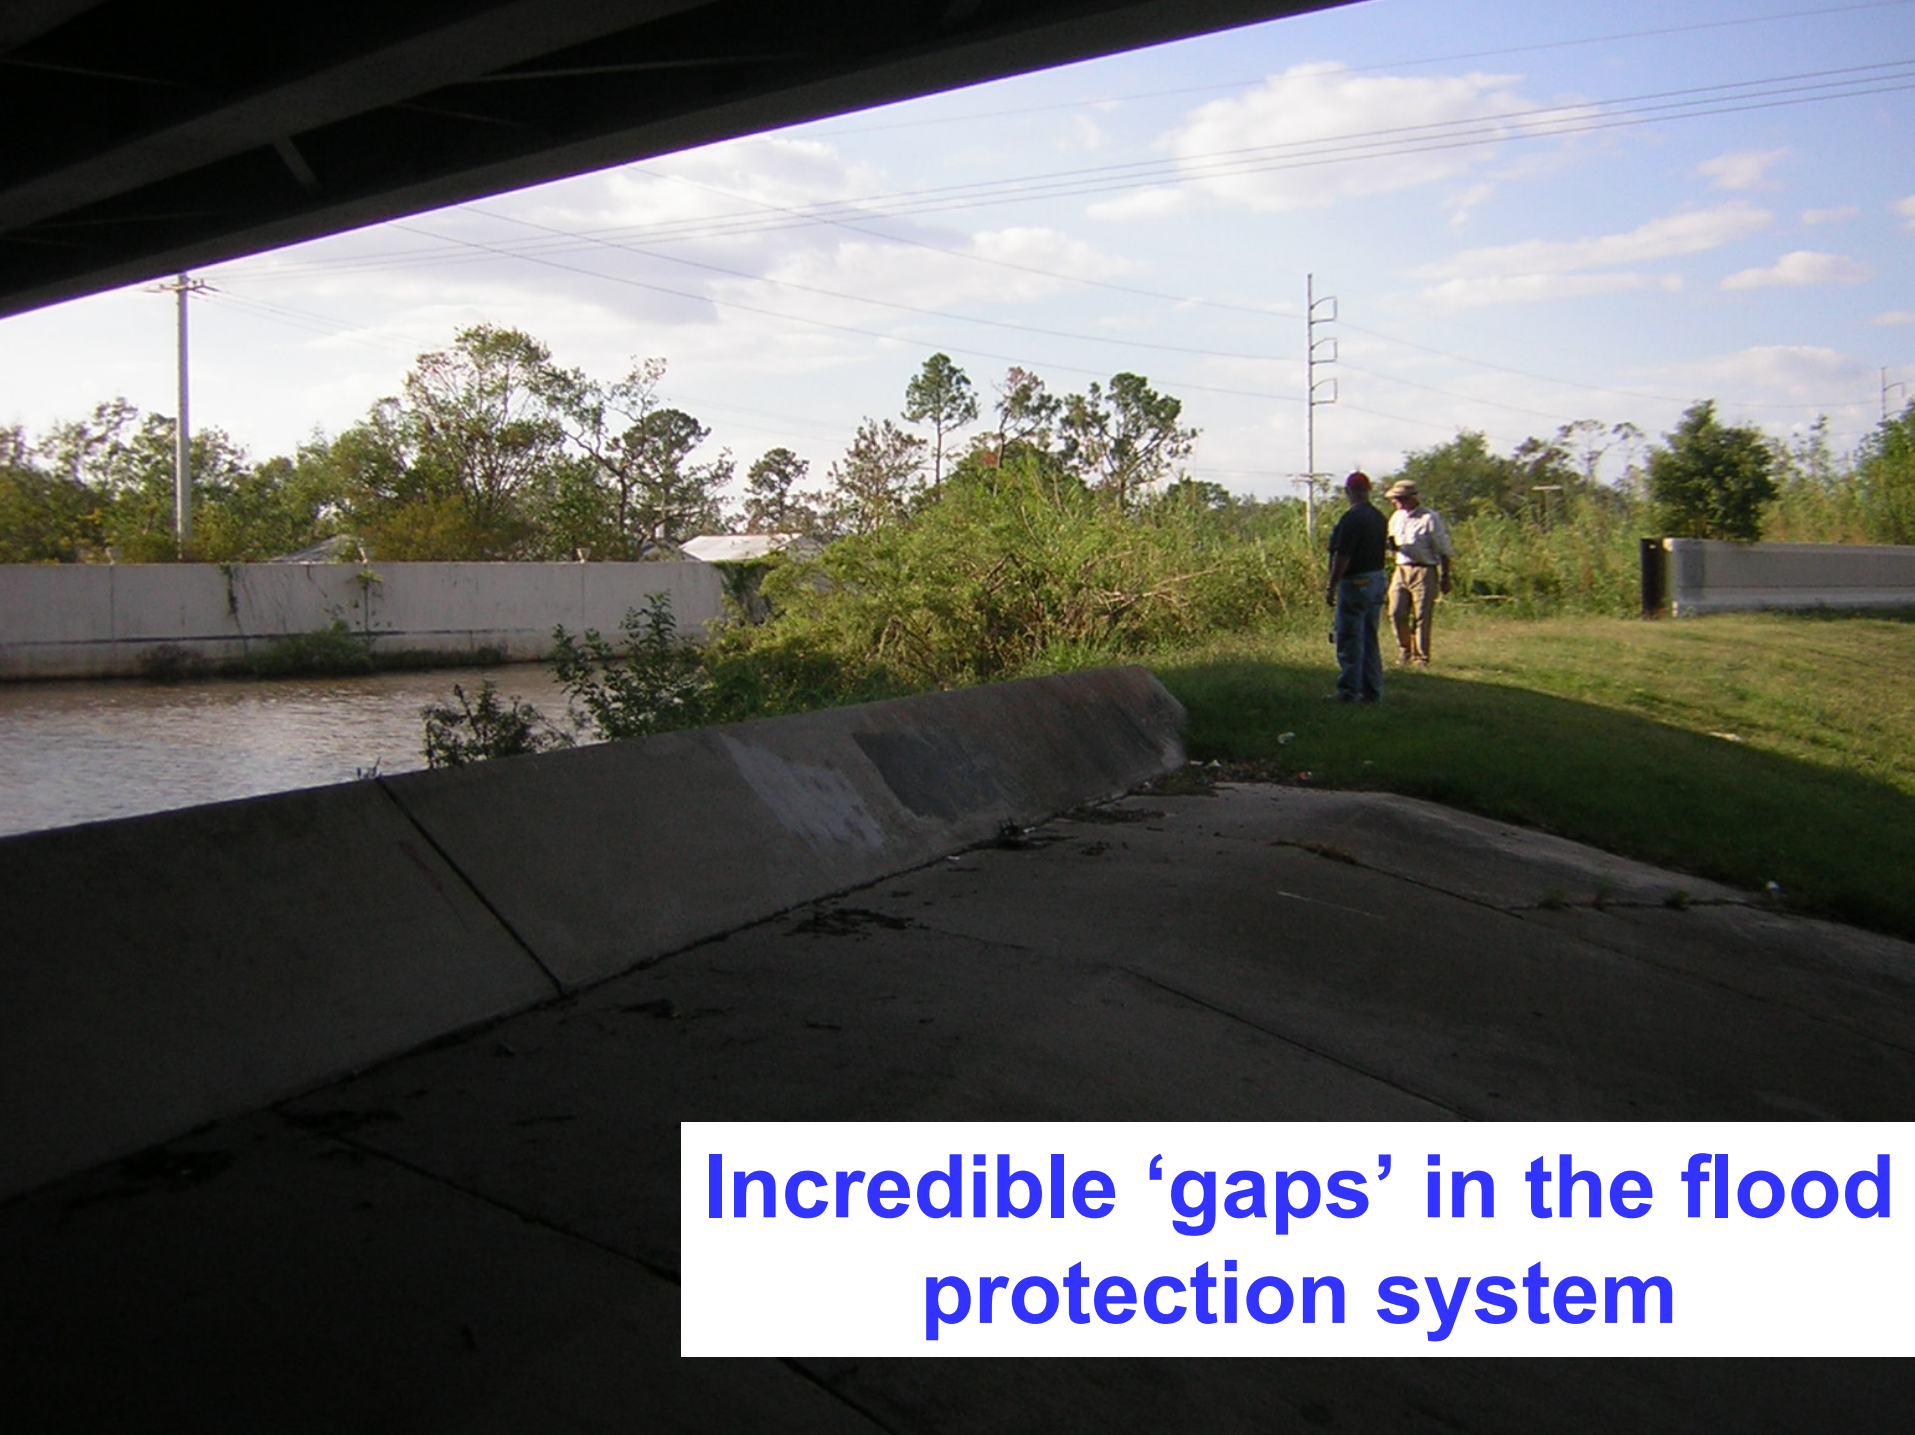
Incredible 'gaps' in the flood protection system
